Property Inspection Report

123 Main Street, Baltimore, MD
Inspection prepared for: Henry Jones & Sally Jones
Real Estate Agent: My Agent - Coldwell Banker

Date of Inspection: 7/2/2015 Time: 3pm
Age of Home: 1923 Size: 3500
Weather: Overcast, 70's

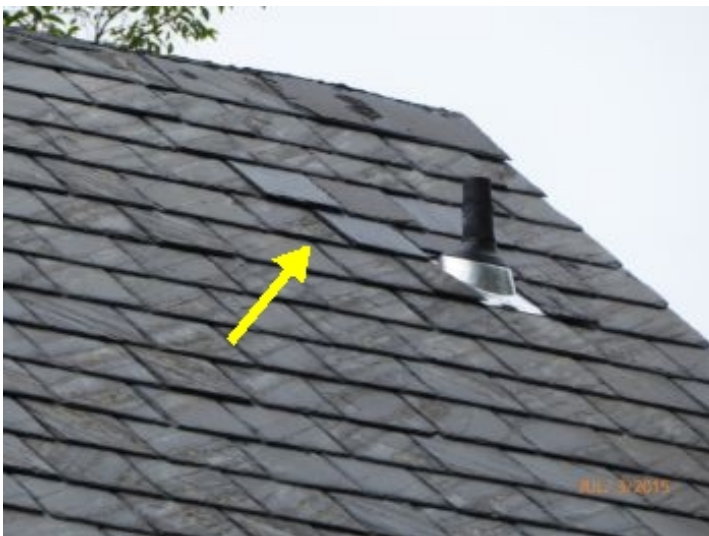
Replaced shingles

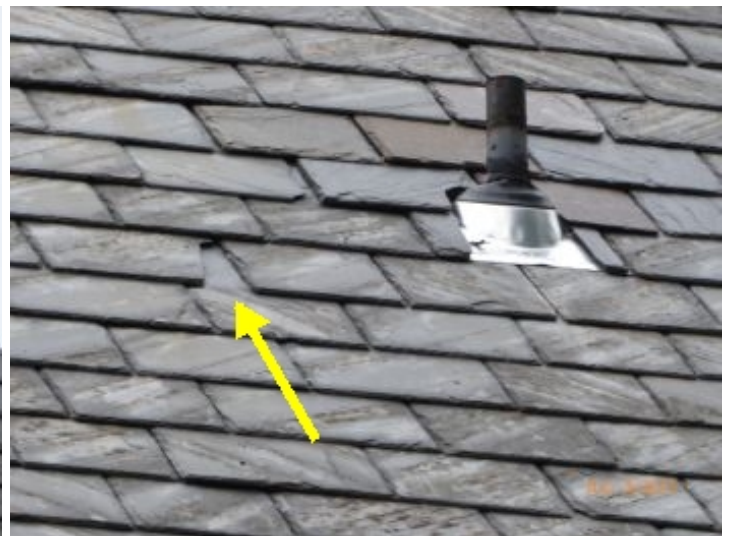
Some cracked shingles. Have licensed roofer repair as needed.

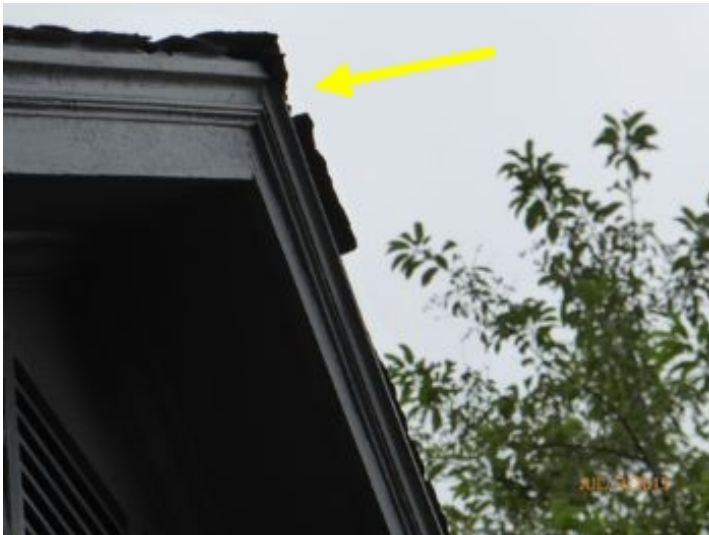
Damage to eave shingles

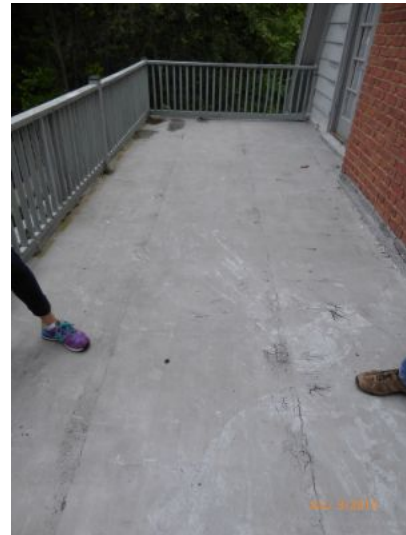
Modified bitumen (rubber roofing) shows some deterioration, surface cracking. Recommend evaluation by licensed roofer.

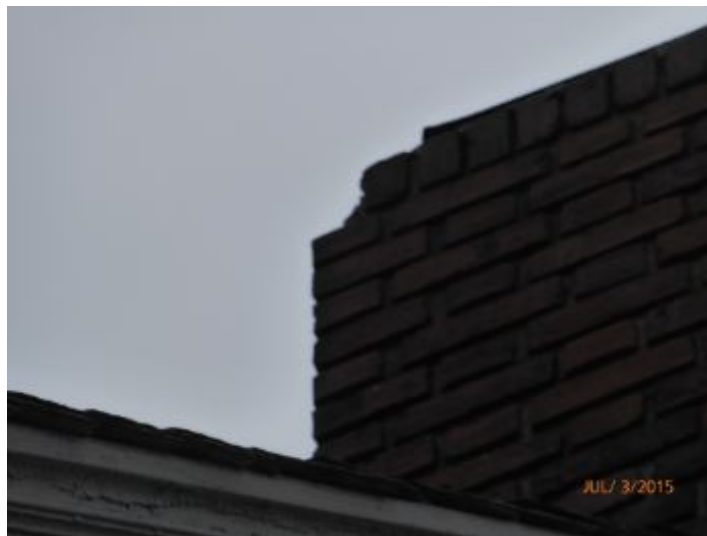
Missing bricks on chimney. Recommend repair by licensed contractor.

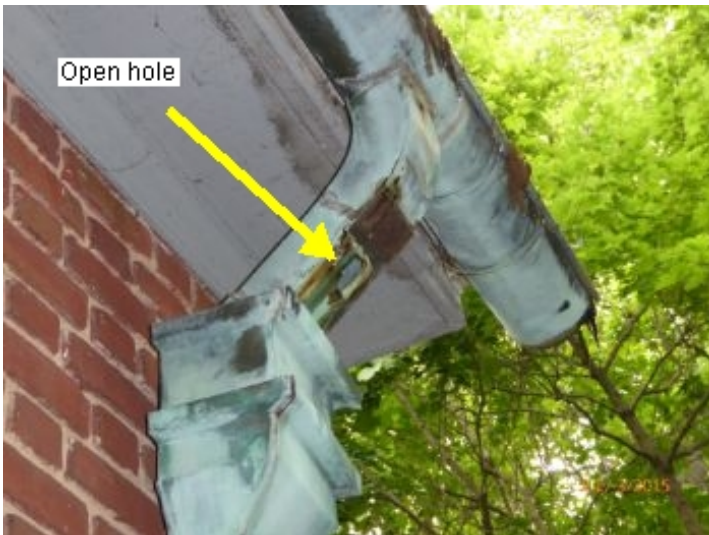
Some deteriorated gutters and downspouts.
Repair/replace as needed.

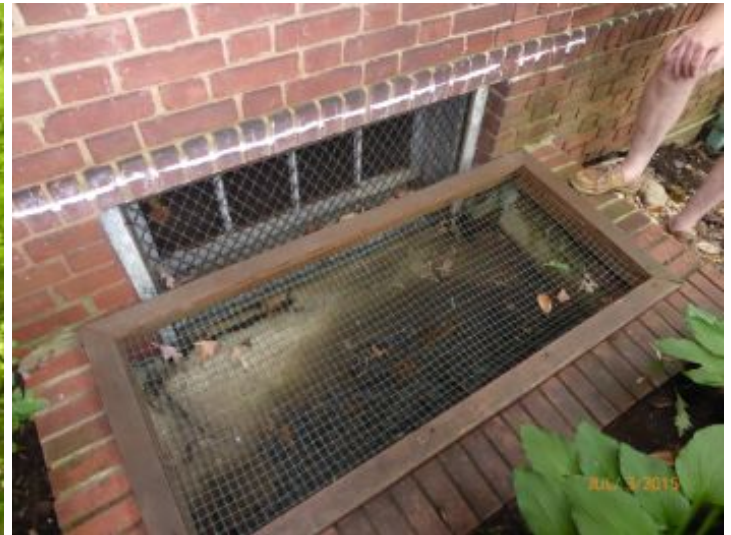
Keep window well clear of debris to allow for proper drainage

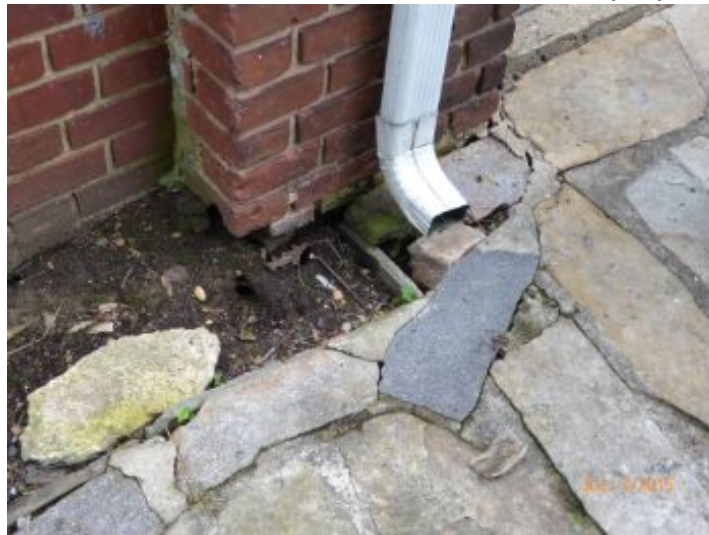
Downspout drains onto sidewalk / driveway. Recommend exploring ways to divert water away from this area, or at the very least, recognize this as a potential ice hazard; use ice melt products and exercise caution.

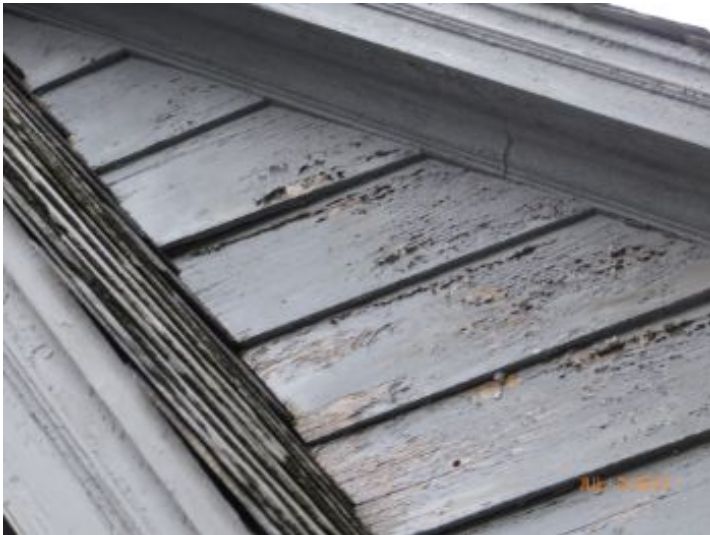
Deterioration of trim/siding. Recommend repair/maintenance.

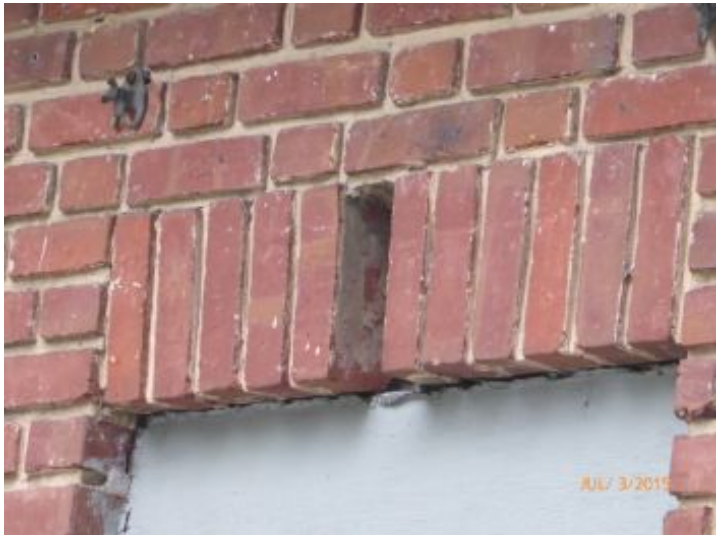
Missing brick, rear.

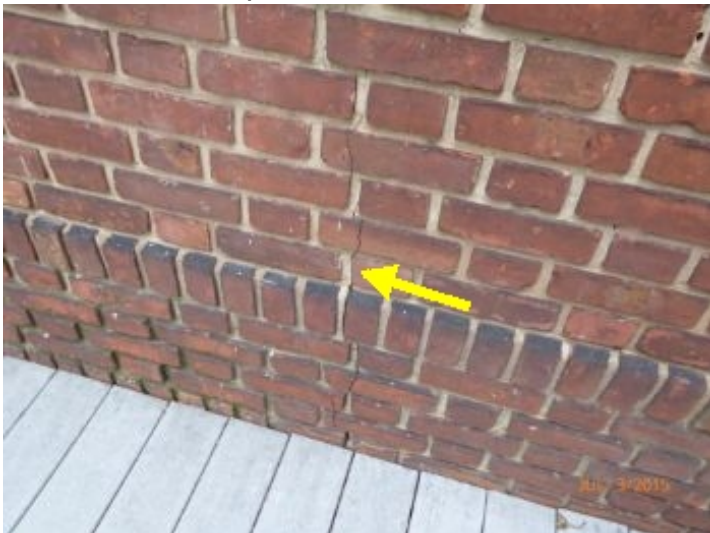
Minor settlement cracks in brick. Recommend sealing/monitoring.

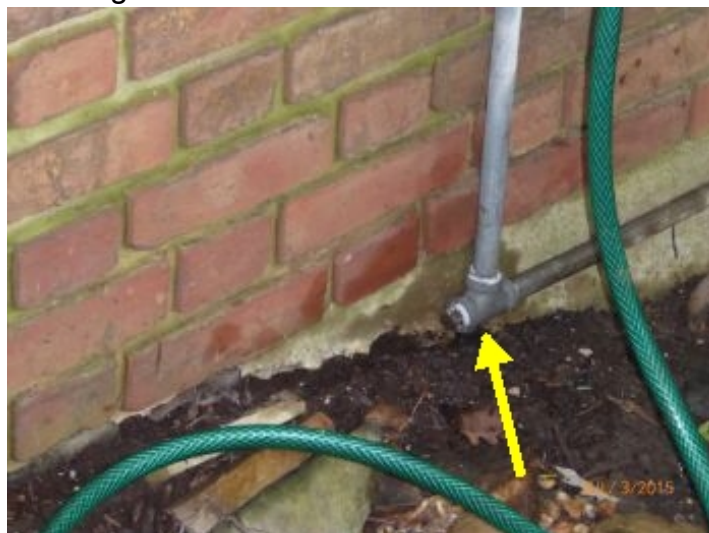
Leaking water pipe front

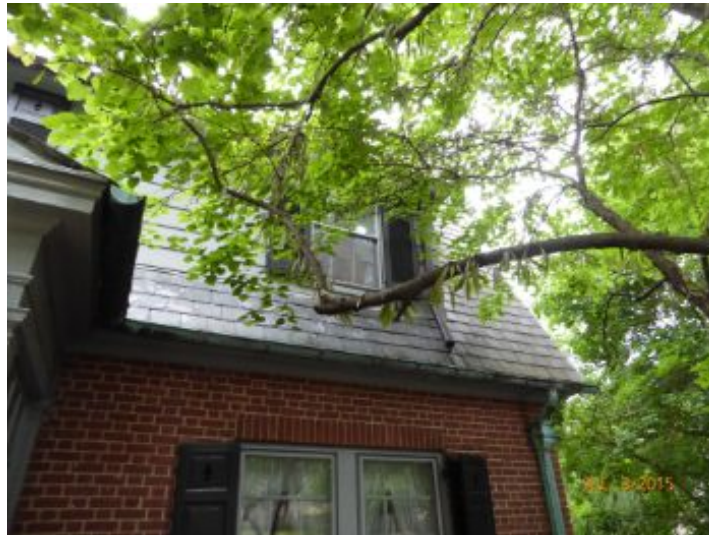
Tree branches overhanging roof. Recommend trimming back to prevent roof damage.

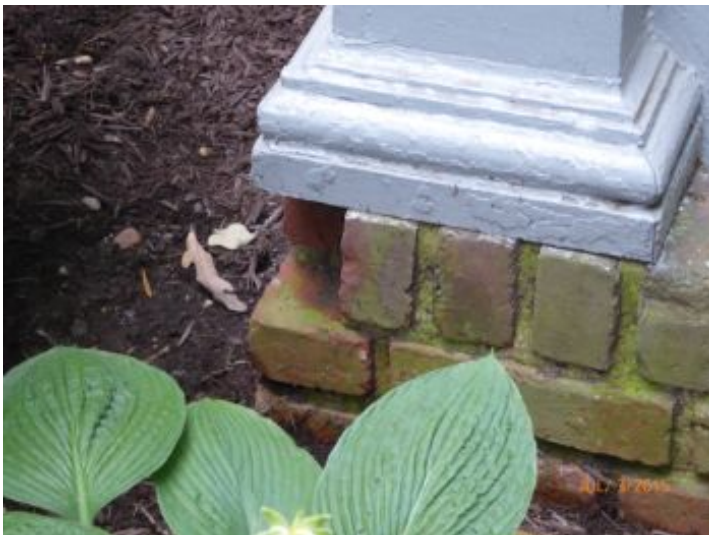
Missing brick front porch

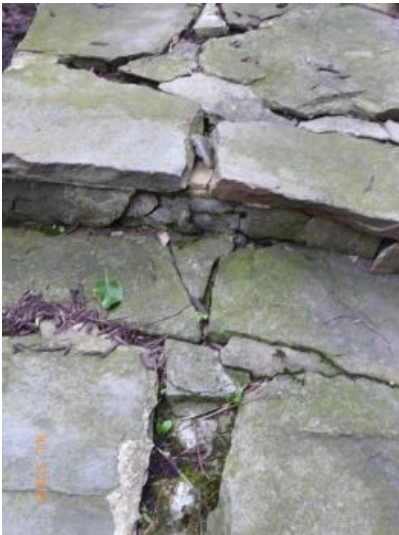
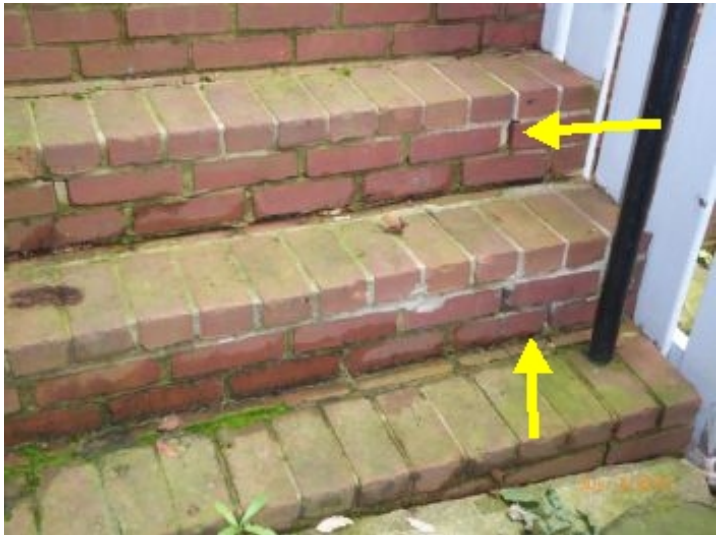
Replace missing mortar as needed.

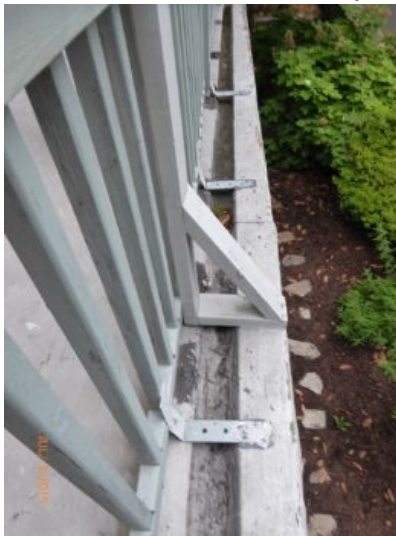
Recommend additional bracing for balcony railing to firm up.

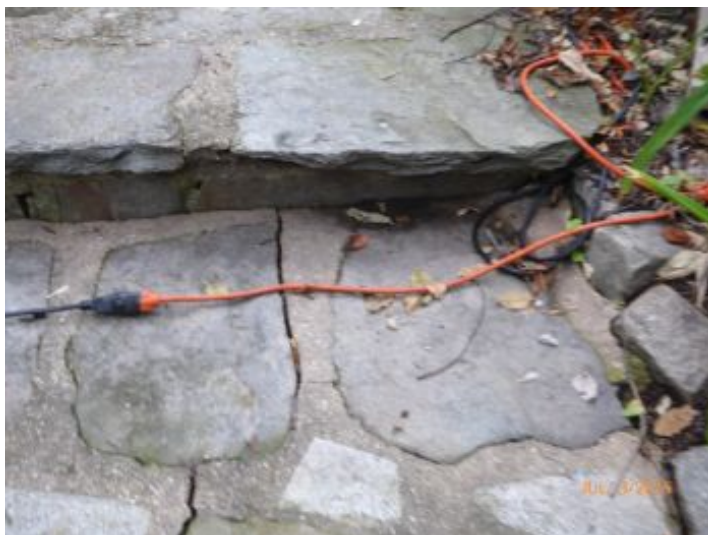
Extension cord used in lieu of properly installed hardwired circuit. Remove or hardwire properly

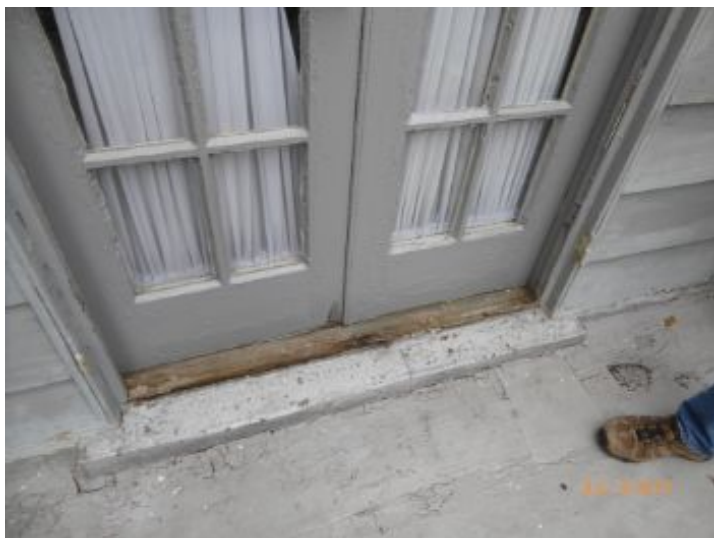
Recommend installing storm doors to help prevent moisture intrusion

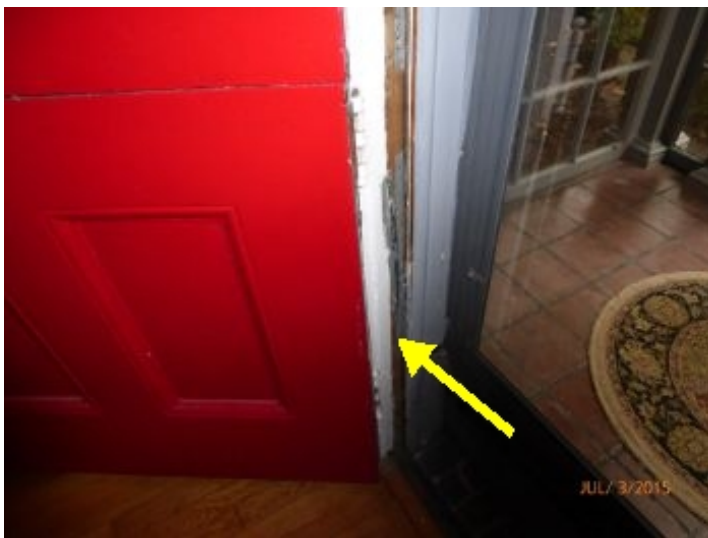
Front door weather stripping incomplete.

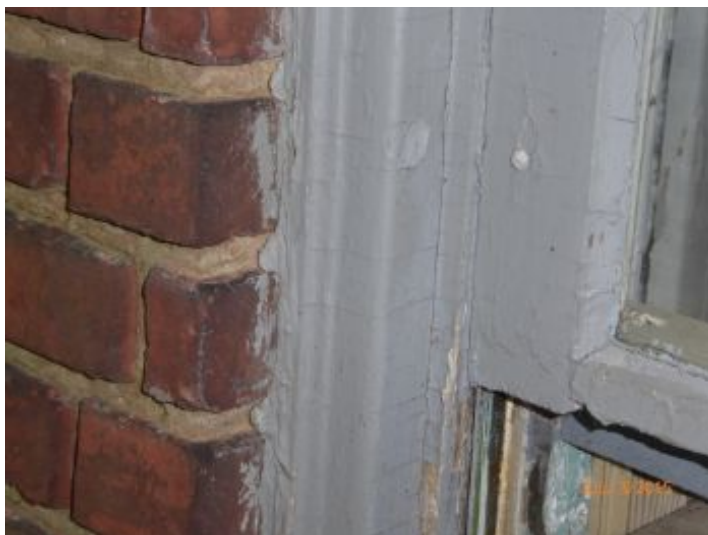
Deterioration of some window and door trim. Recommend caulking and painting as necessary.

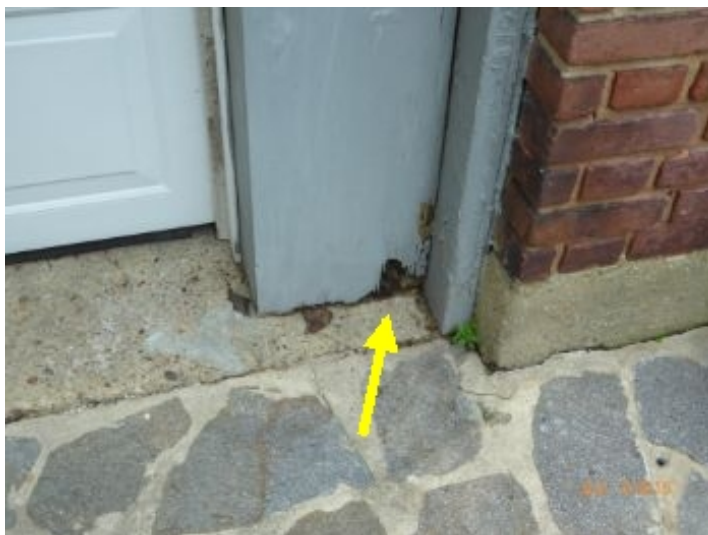
Door jamb(s) deteriorated, repair as needed.

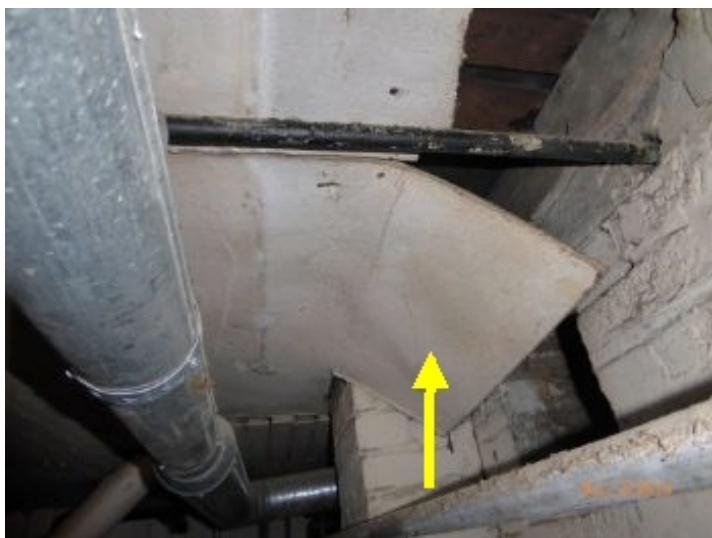
Panels above boiler may contain asbestos, recommend testing.

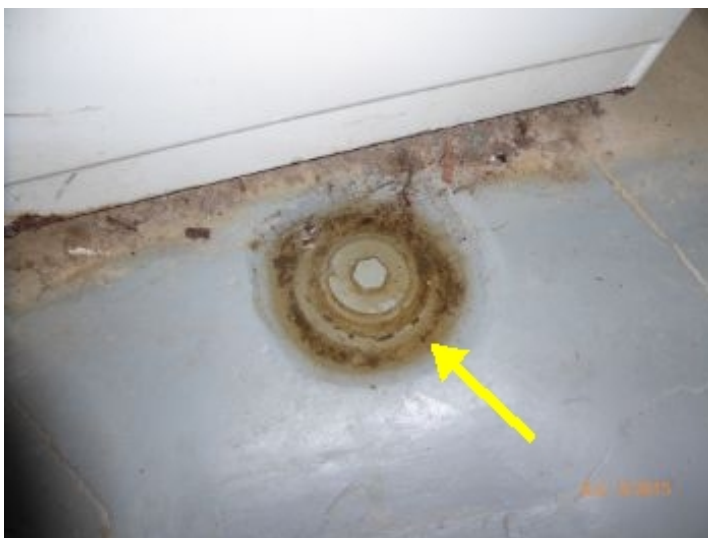
Standing water at waste water cleanout. Unknown source.

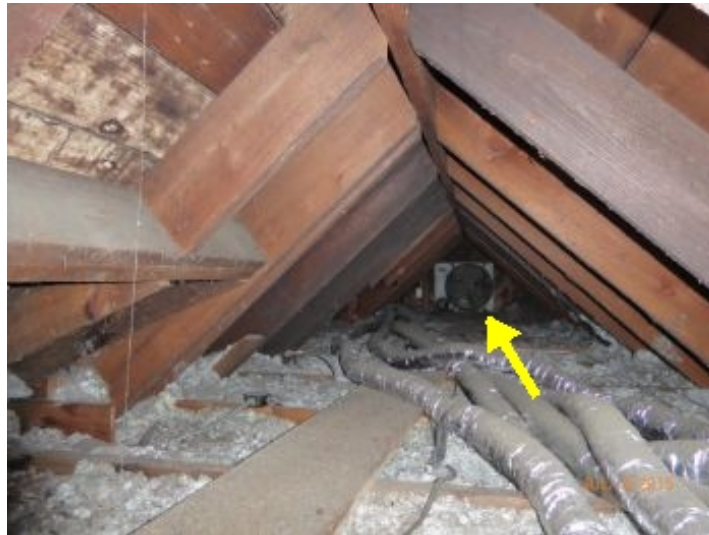
Attic exhaust fan, could not determine if operational. Have licensed electrician evaluate

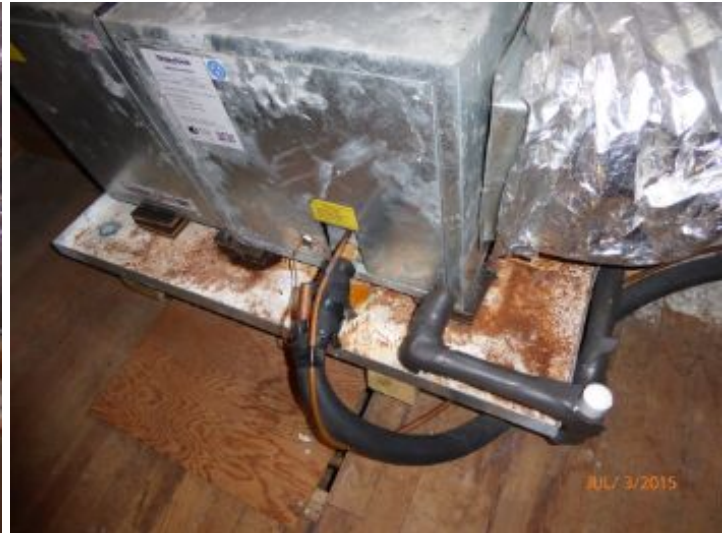
Recommend installing condensate catch pan cutoff switch

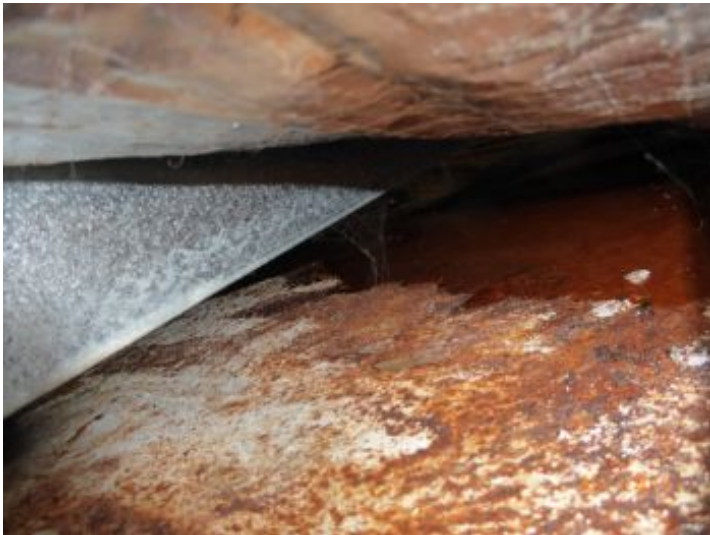
Standing water in condensate catch pan. Have licensed HVAC tech evaluate/correct

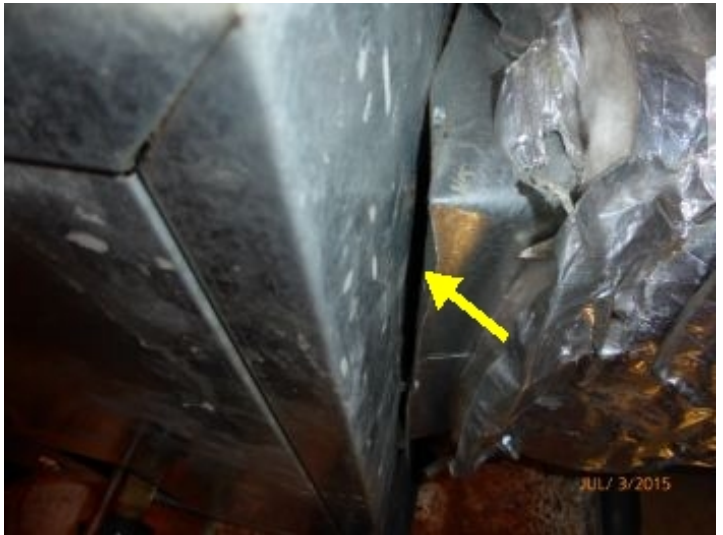
Open duct work at air handler. Have tech seal properly

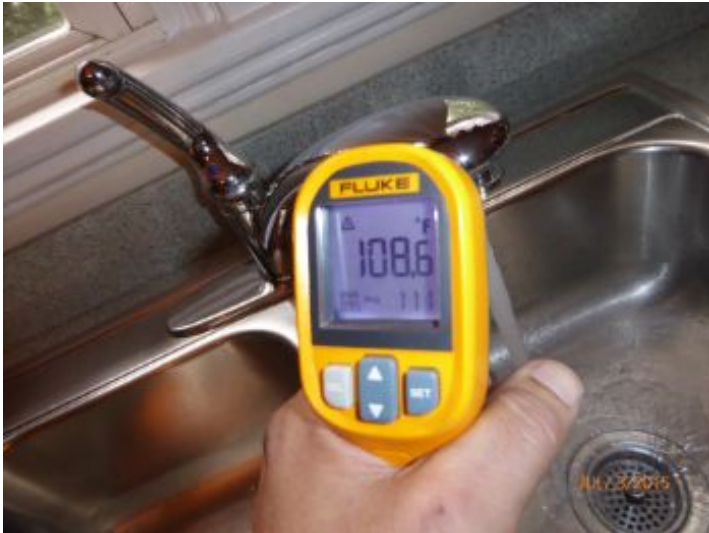
Recommend setting water temperature at 115 to 120 degrees.

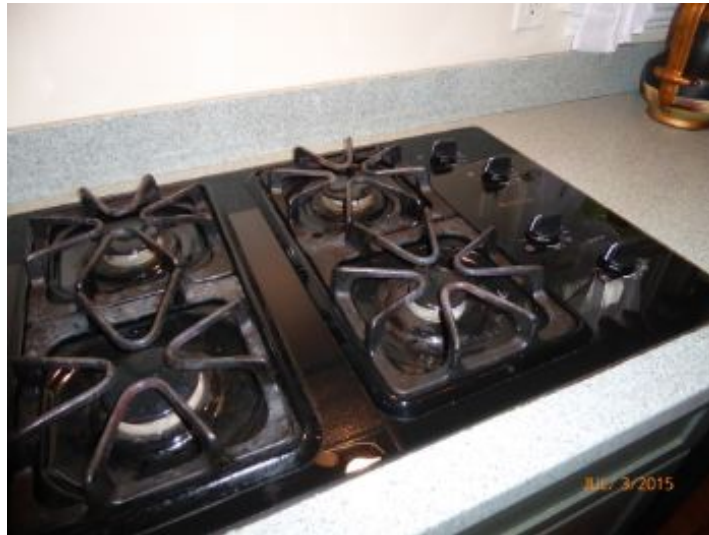
- **Stove did not operate from controls**

Burners not lighting

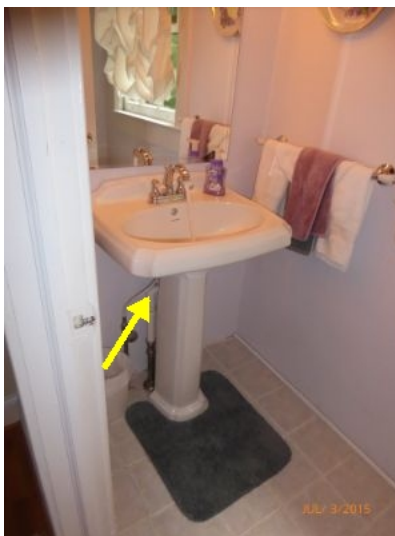
- **Sink drain line leaks.**

Minor leak under sink.

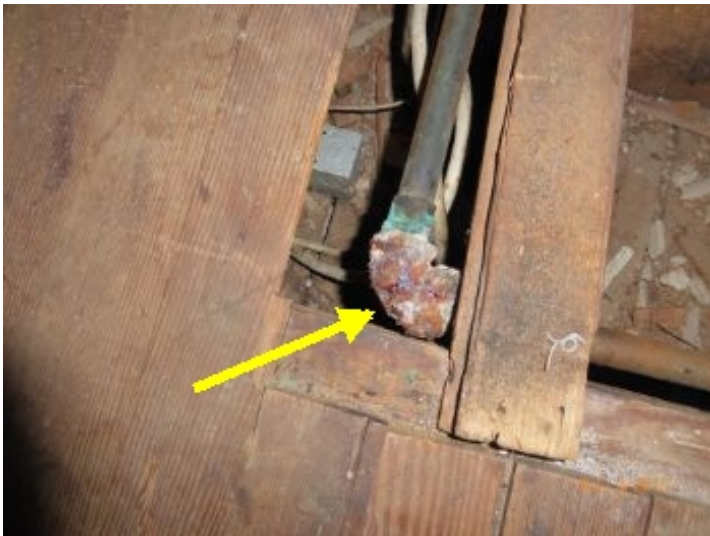
Corroded pipe visible in air handler closet. Have licensed plumber evaluate. Maybe due to galvanic corrosion

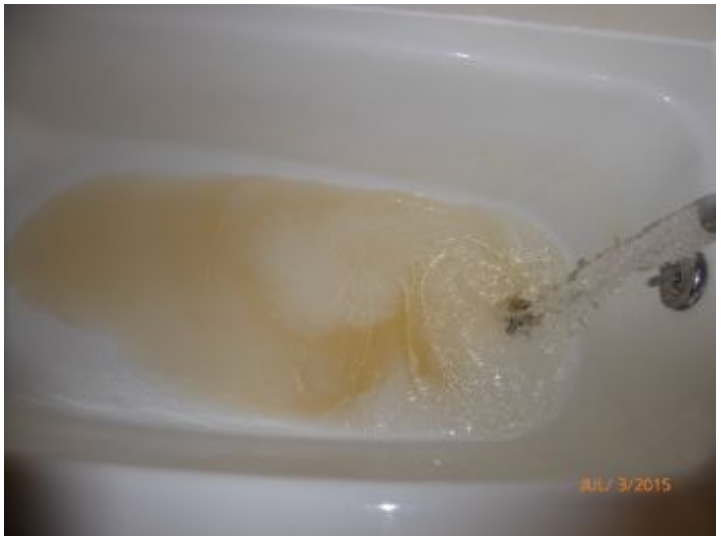
Tea colored water present, may indicate some galvanized supply pipes.

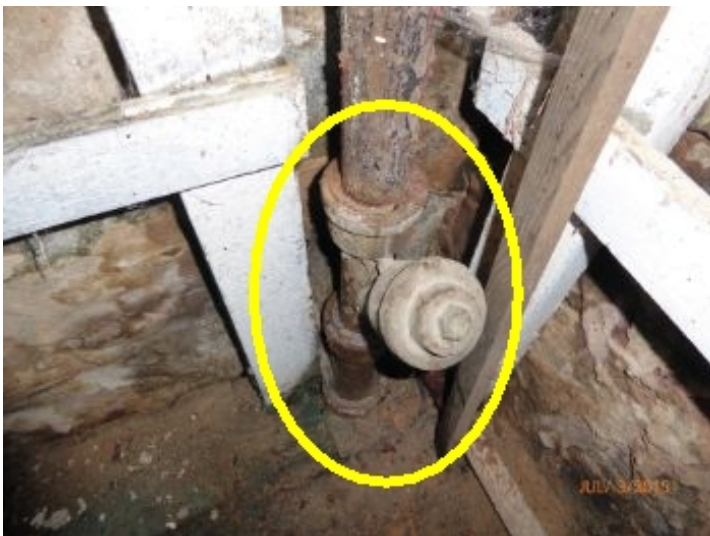
Leaking drain pipe, basement closet. Have licensed plumber repair

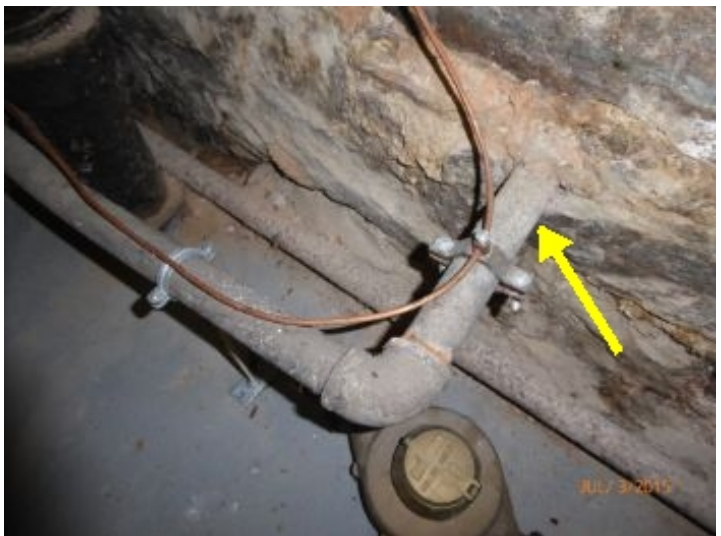
Galvanized main water supply. Monitor for replacement, may fail without warning

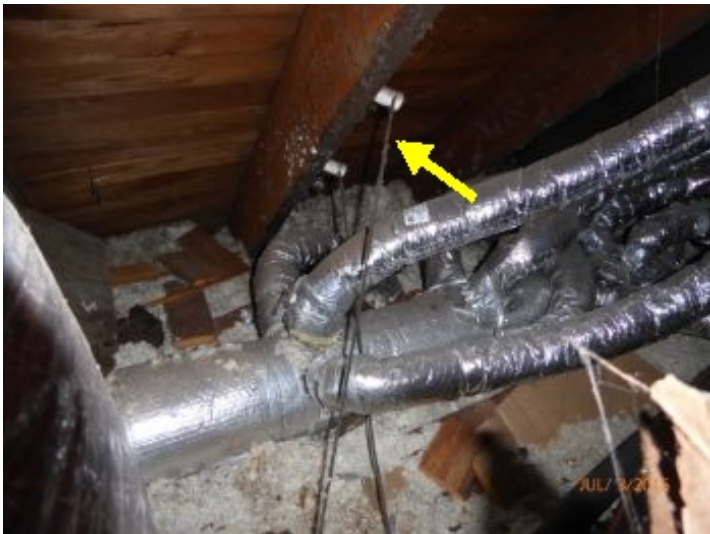
Knob and tube wiring in attic, tested active at time of inspection. Have licensed electrician evaluate

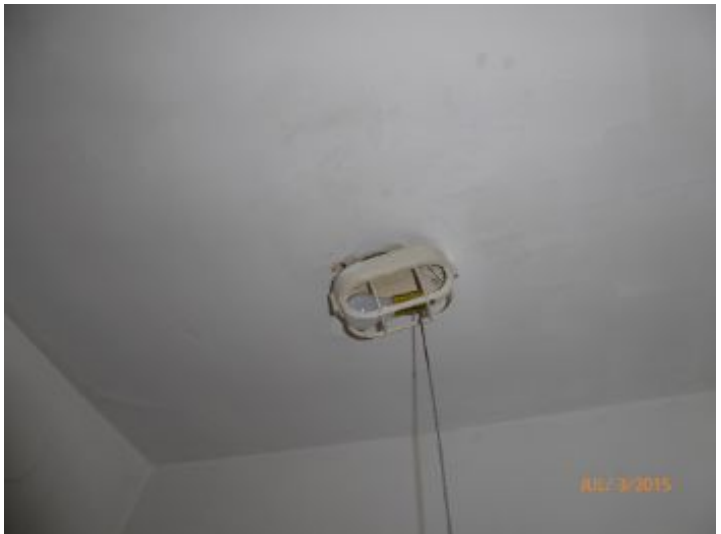
Semi detached fixture, coat closet, first floor

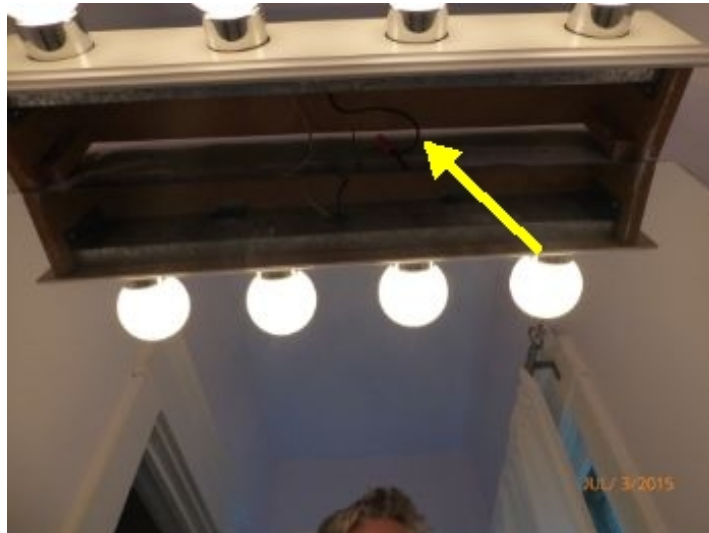
Exposed wiring bath fixture, guest bath. Have licensed electrician correct

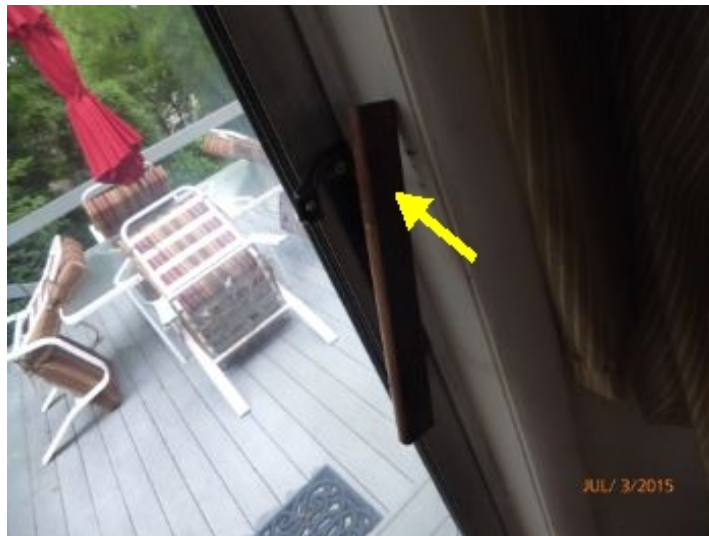
Detached handle, sliding door

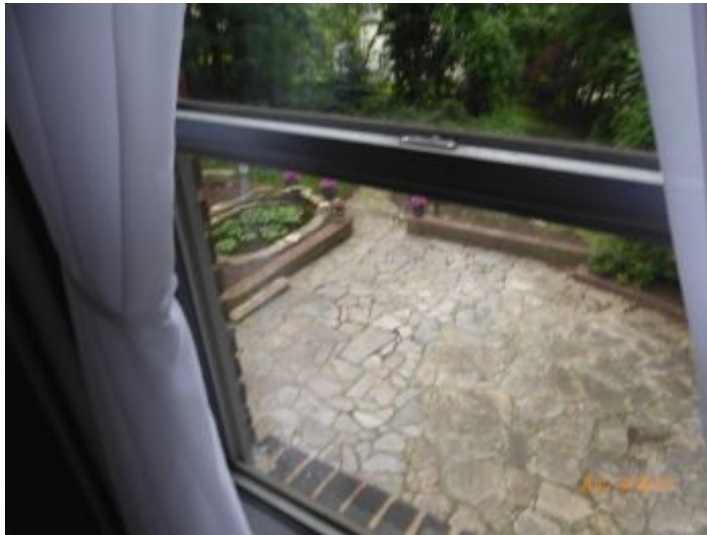
Older aluminum window near kitchen, does not appear to close properly. Recommend replacement

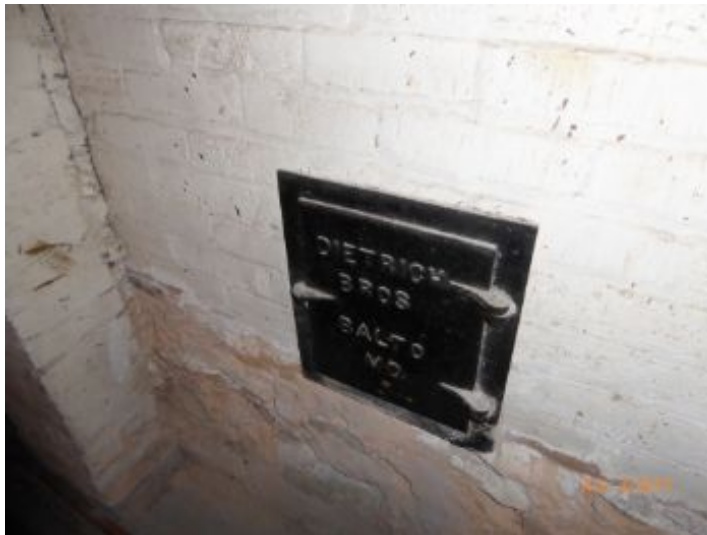
Ash dump full, recommend clearing.

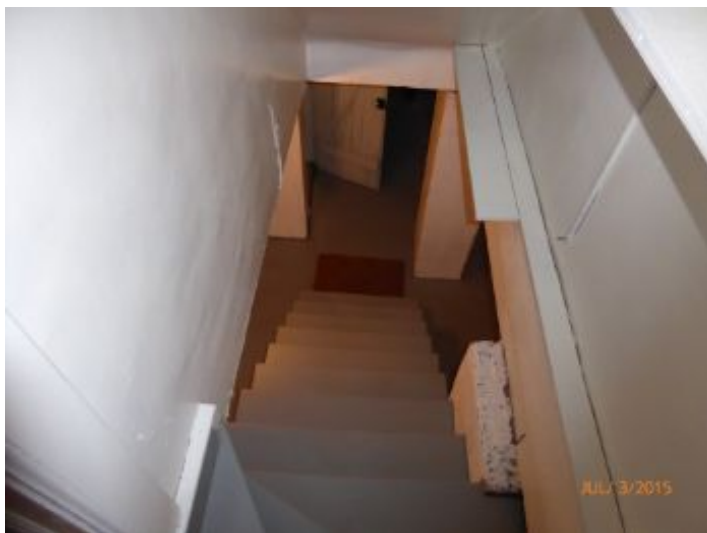
Hand Rail Components missing at basement stairs.
