Property Inspection Report

Avocet Inspections LLC

123 Commercial Blvd, Baltimore, MD 21222
Inspection prepared for: John Smith - AAA Manufacturing
Date of Inspection: 5/12/2017 Time: 9:30am
Age of Home: C. 1930 Size: 13000+ sq. ft.
Weather: Overcast, light rain, 74°

Note- This was a commercial building inspection performed for informational purposes

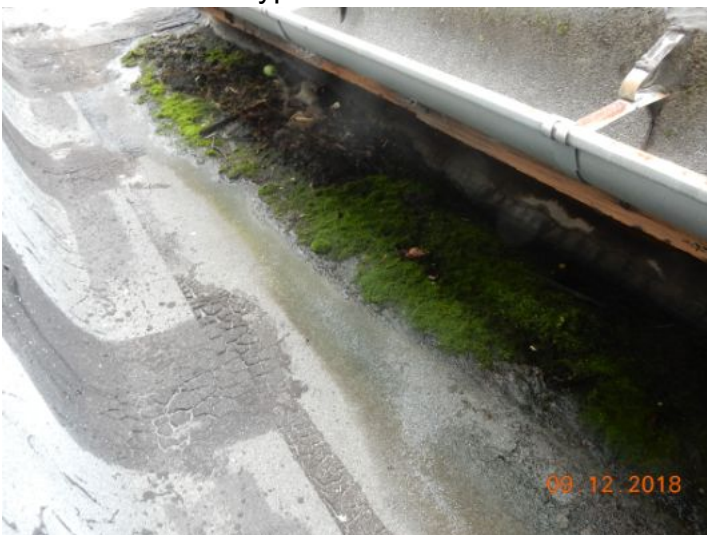
Moss/lichen on roof. This can lead to the premature failure of the roof and subsequent leaks. Recommend treating moss during with a zinc compound to help prevent deterioration.

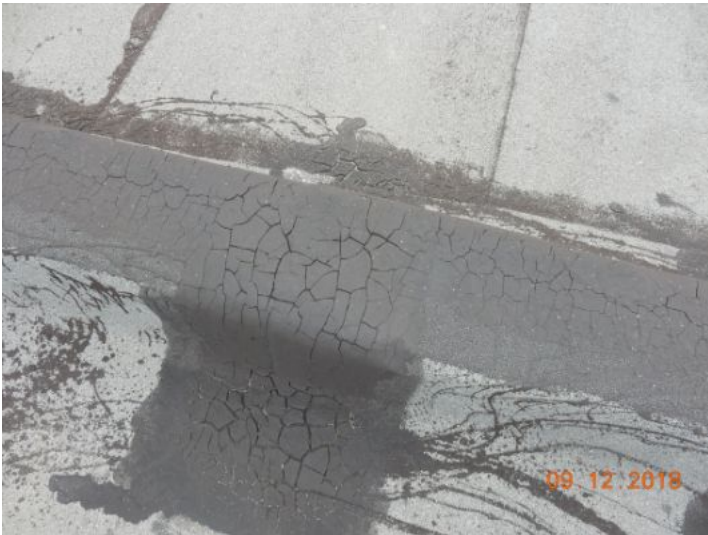
- **Granulated rubber roofing, older, shows some granulation loss. Cracking of asphalt at seams. Recommend patching cracked asphalt areas. Recommend coating entire roof with white roof coating or other to help seal roofing and prolong useable life span.**

Asphalt cracked, recommend sealing

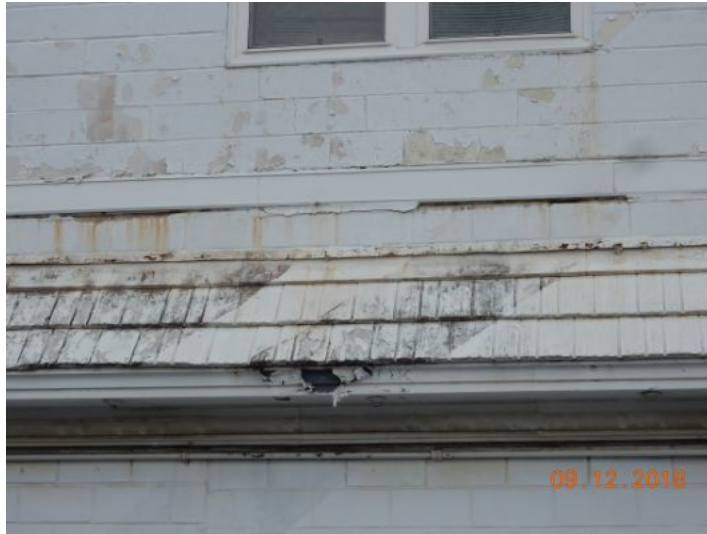
Front mansard roof may be leaking to interior

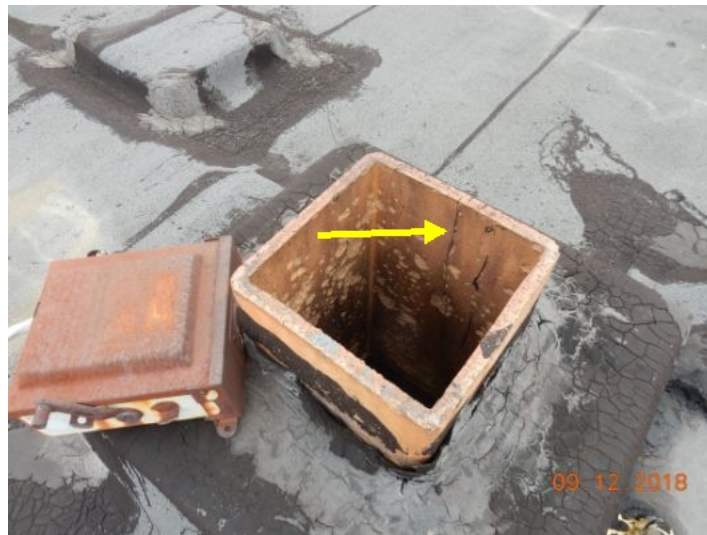
- **Chimney flue is cracked. See photo.**

Chimney flue is cracked.

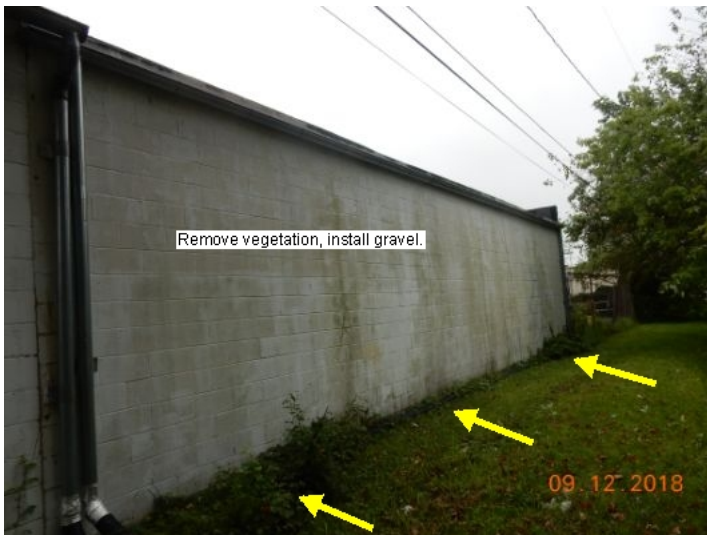
Improve grading as necessary to drain water away from structure

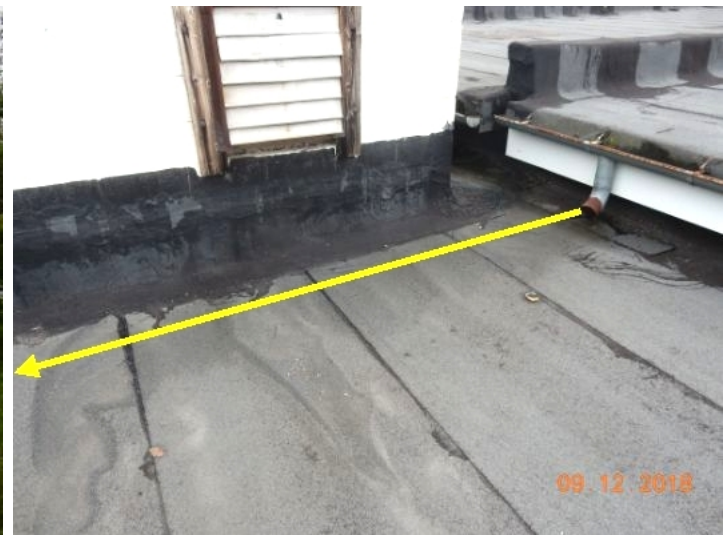
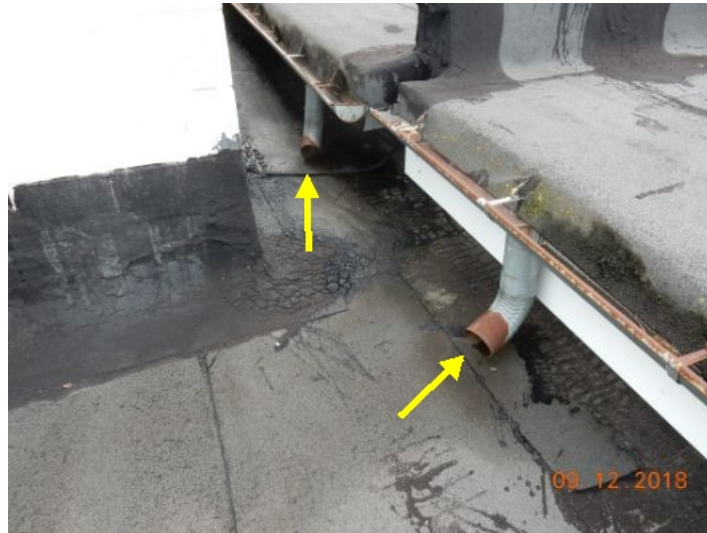
Recommend directing roof downspouts to gutter below

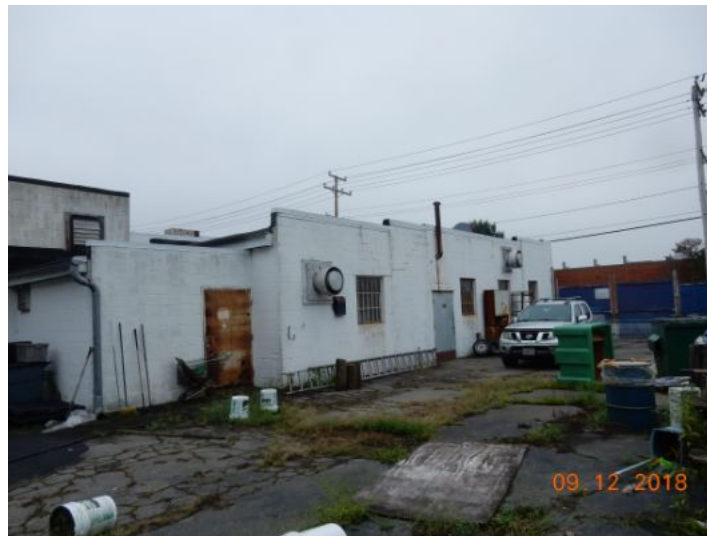
Parking, loading area

- **Asphalt driveways, parking areas show cracking/buckling. Recommend replacing as necessary.**

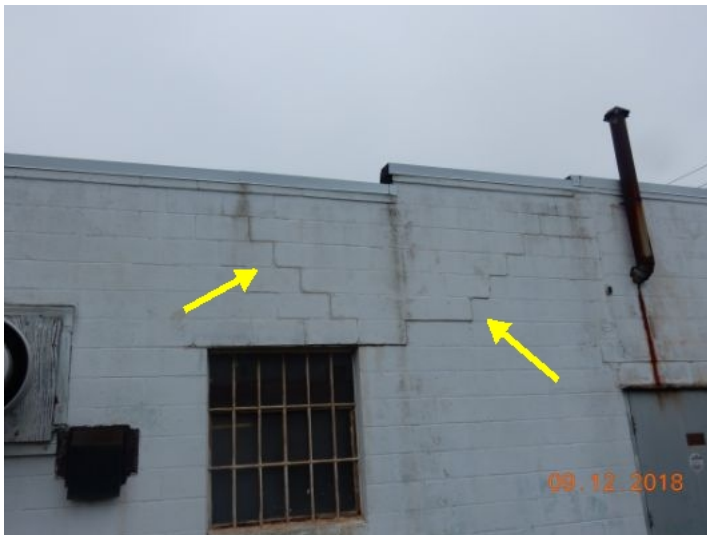
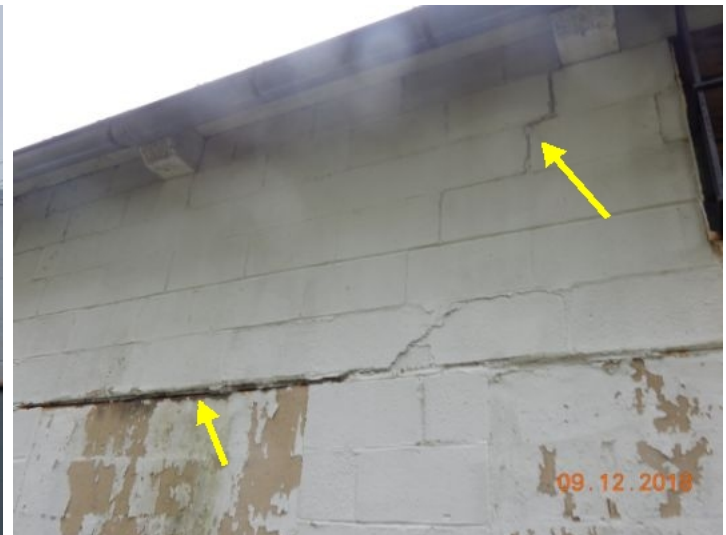
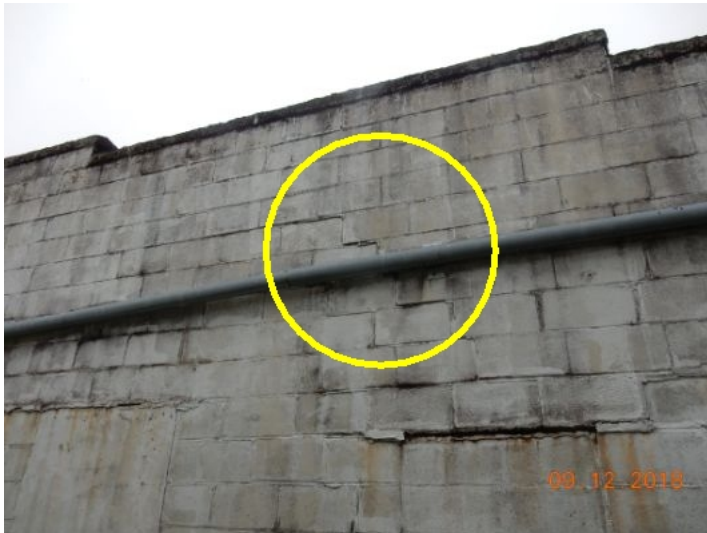
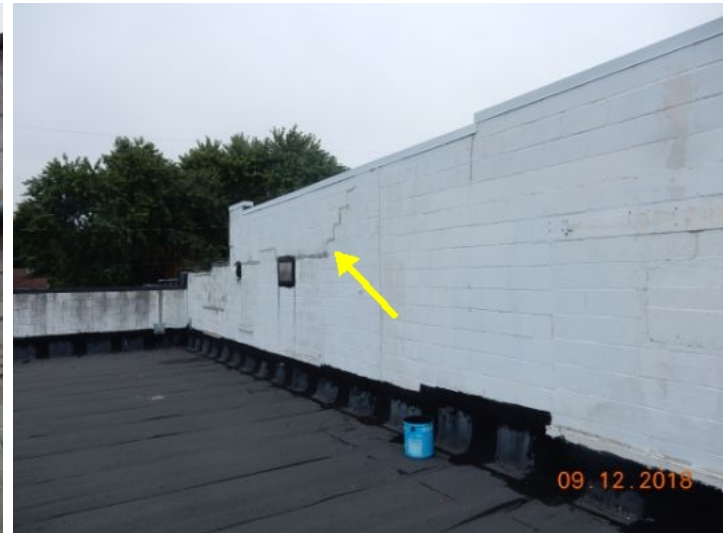
- **Some settlement cracking at concrete block walls, various locations. Cracks are fairly typical for an older masonry structure. Recommend sealing cracks and monitoring.**

Some settlement cracking at concrete block walls, various locations. Cracks are fairly typical for an older masonry structure. Recommend sealing cracks and monitoring.

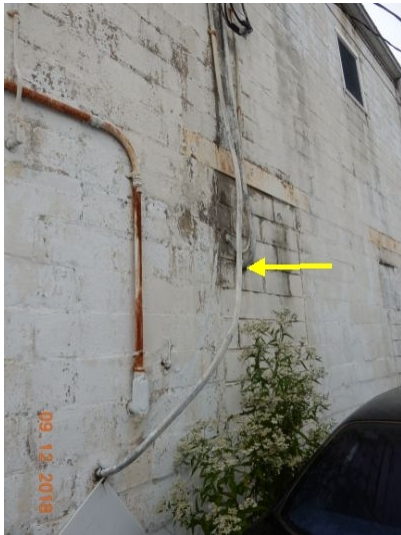
Secure loose service entrance cable to side wall.

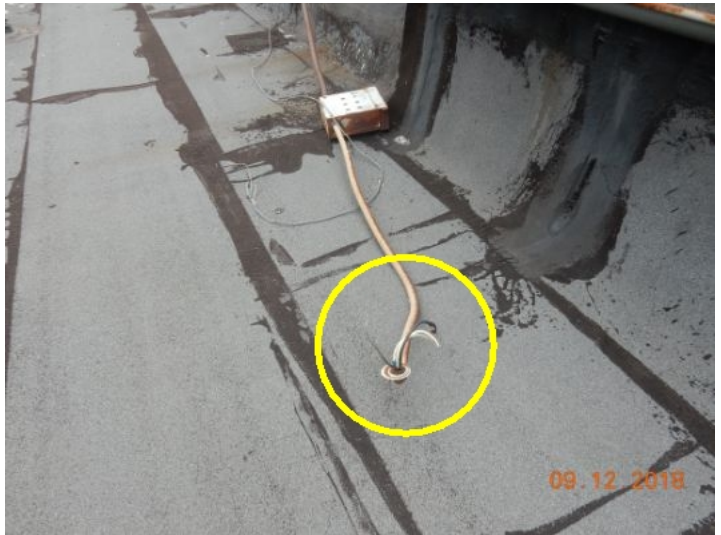
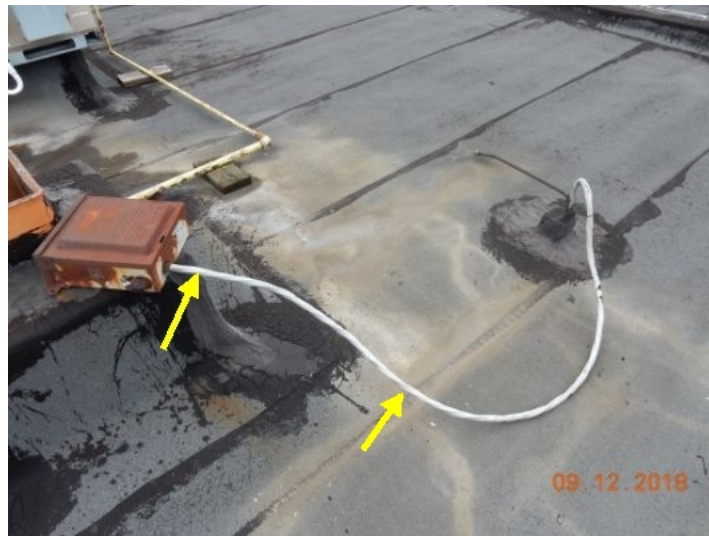
- **Exposed live wiring at 2 roof locations. Electrocutation hazard. Have licensed electrician remove abandoned wiring. See photos.**
- **Secure loose service entrance cable to side wall. See photo.**

Exposed live wiring at 2 roof locations. Electrocutation hazard. Have licensed electrician remove abandoned wiring. See photos.

Exposed live wiring at 2 roof locations. Electrocutation hazard. Have licensed electrician remove abandoned wiring.

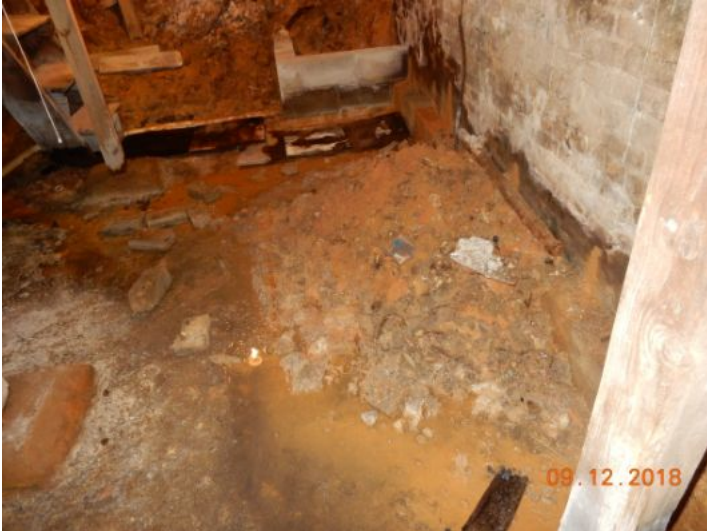
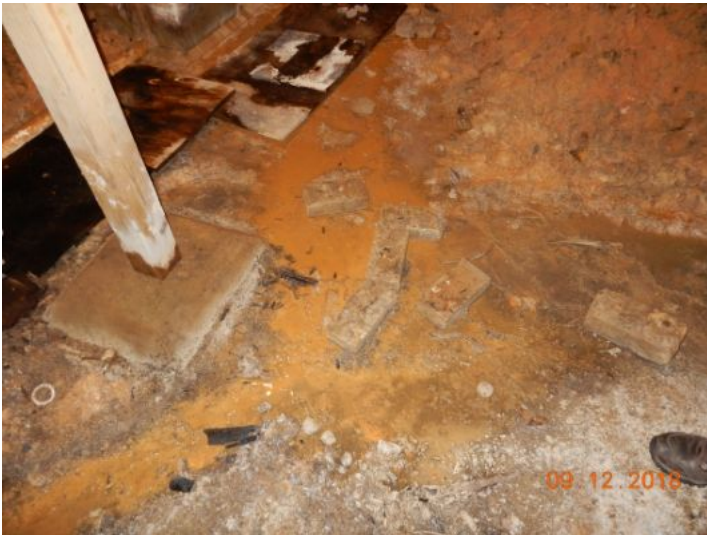
Water pooling in basement

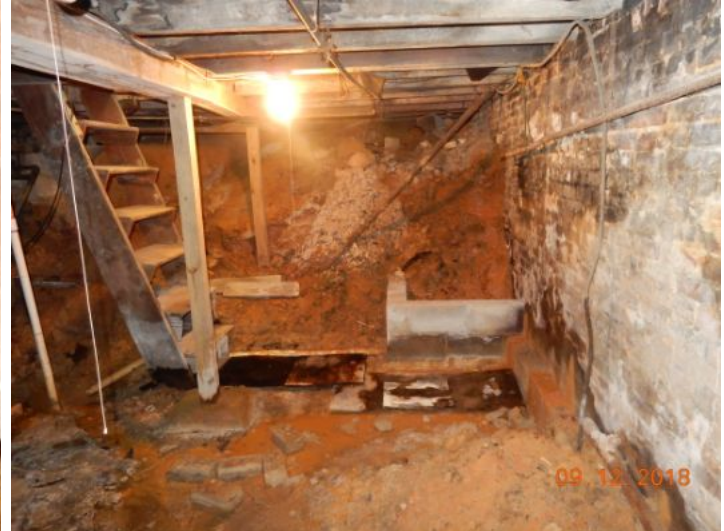
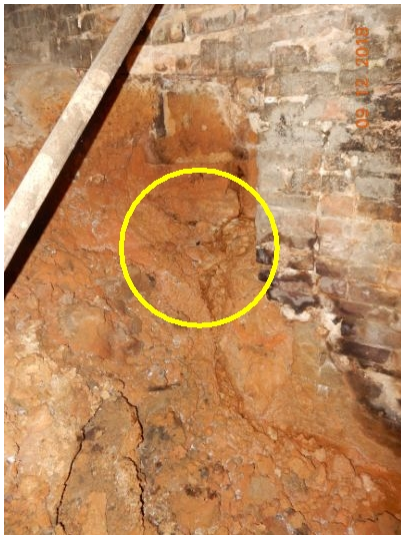
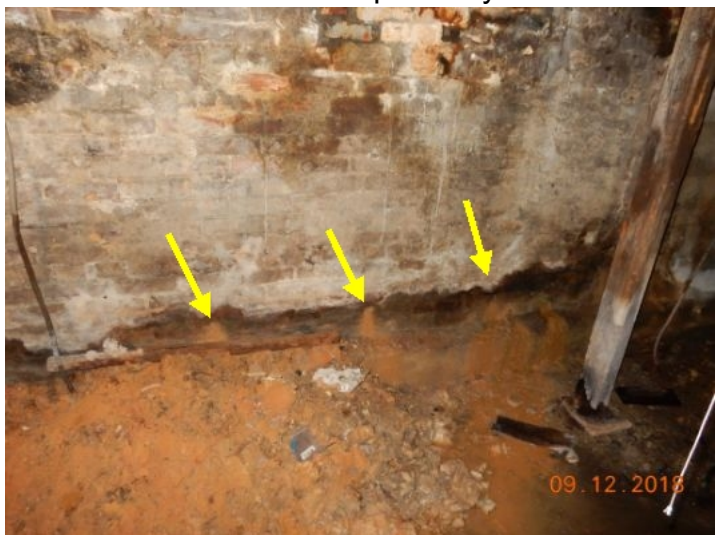
Basement - active water intrusion

Active water intrusion noted, unknown source.

Water intrusion points, source unknown

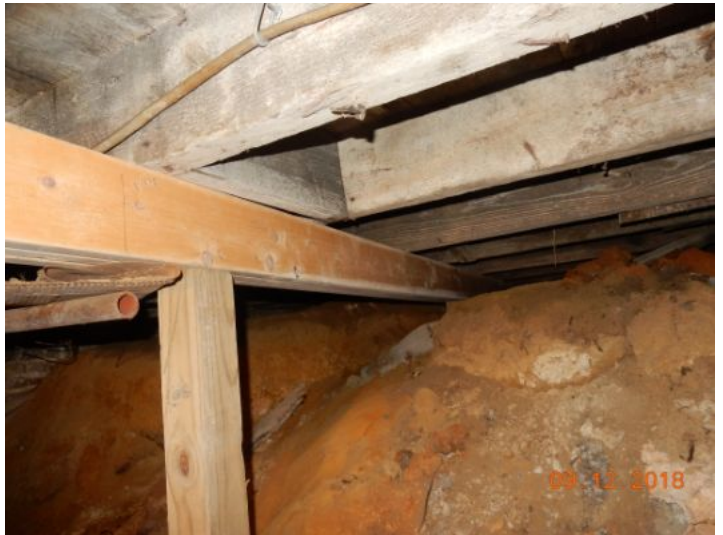
Framing and soil in close proximity, can lead to framing damage

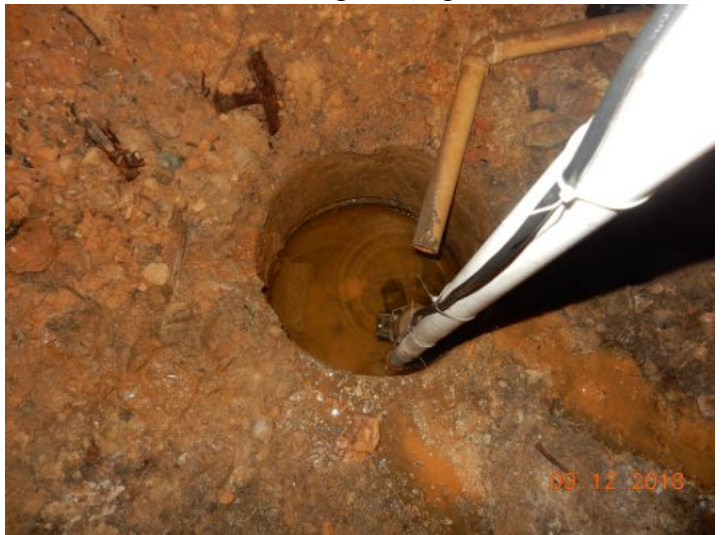
Recommend installing heavy duty sump pump with backup battery

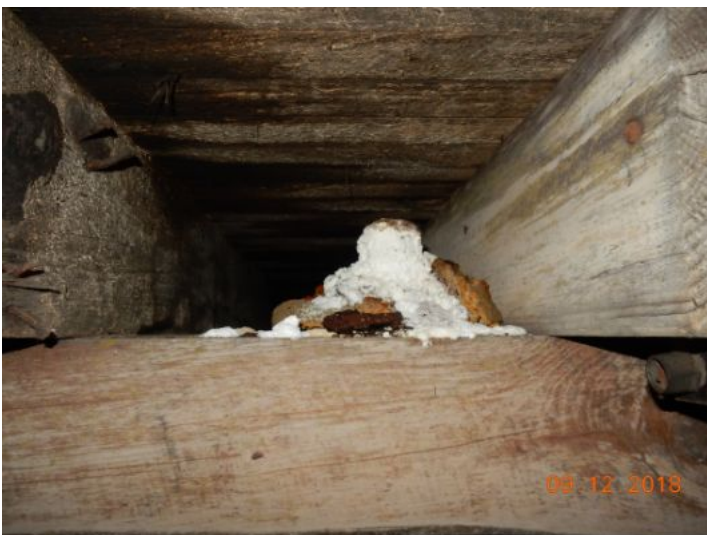
Possible asbestos, recommend testing.

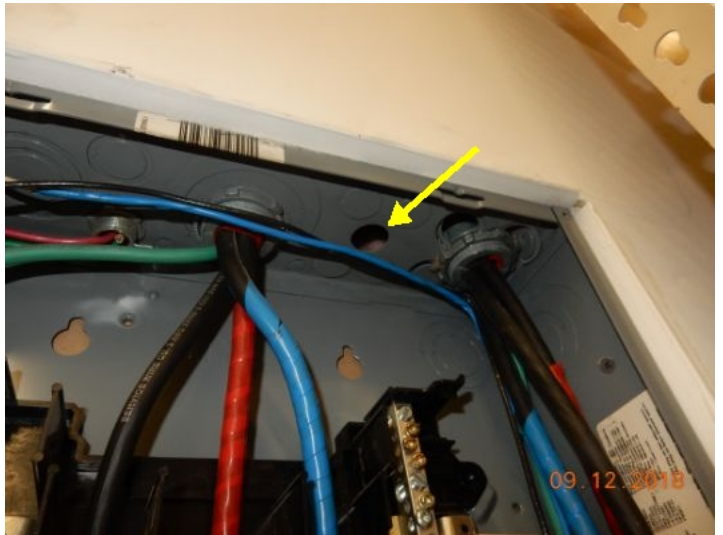
- **Knockouts need snap-in caps inside panel box. Should be installed to keep mice out of panel box and to avoid potential electrocution hazard. Mold room**

Knockouts need snap-in caps inside panel box. Should be installed to keep mice out of panel box and to avoid potential electrocution hazard. Mold room

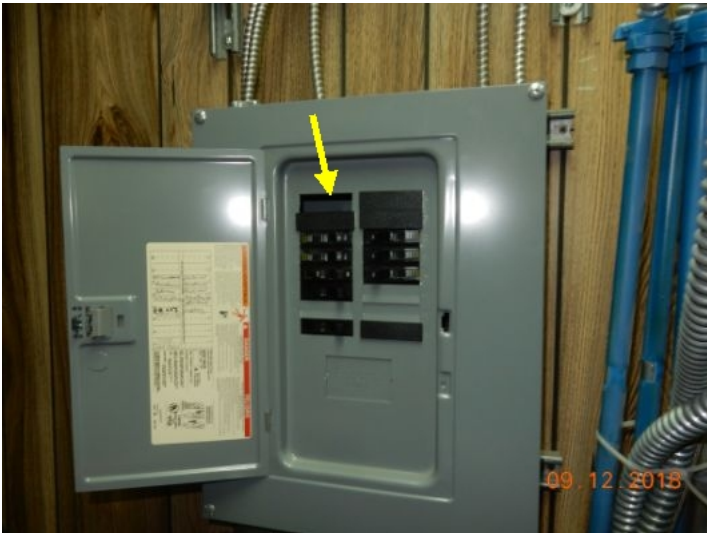
Open knockouts panel enclosure, electrocution hazard, install proper filler plates. - 2nd floor

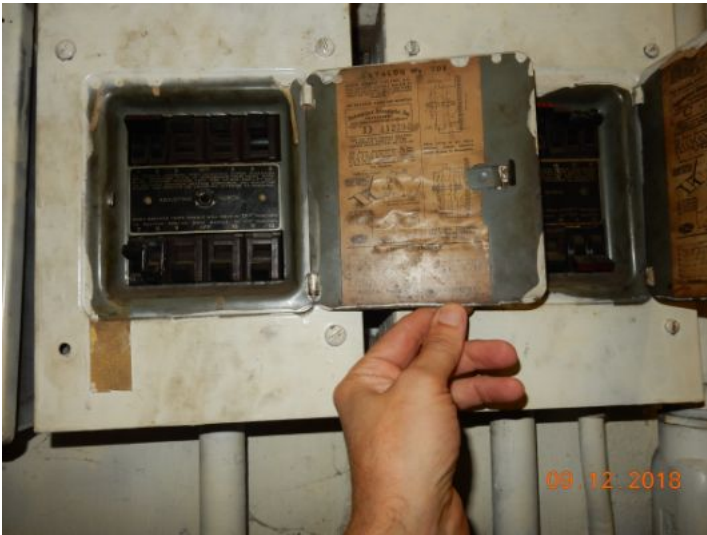
- **There is a Federal Pacific Electric service panel installed. There are studies that show that some FPE circuit breakers are prone to problems that can lead to failures, lack of proper protection of circuits and other serious issues, including fire and electrocution. Although the Consumer Products Safety Commission has not issued a formal product recall, the panel is old and the company is now out of business. We cannot definitively call this panel defective, but recommend, for your peace of mind, to consult a qualified electrical contractor to get their opinion on this matter. You can learn more about this issue at: <http://www.codecheck.com/pdf/electri...%20Nov2003.pdf>, www.inspect-ny.com/fpe/fpepanel.htm, and <http://www.inspect-ny.com/fpe/CPSCsummary.htm>.**

Federal Pacific panels. 2. Consult licensed electrician

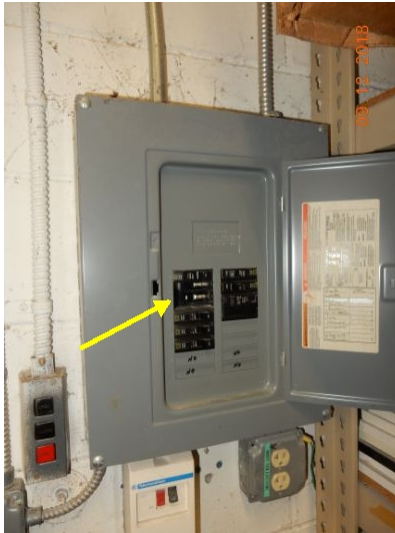
Open knockouts panel enclosure, electrocution hazard, install proper filler plates. Shop/warehouse

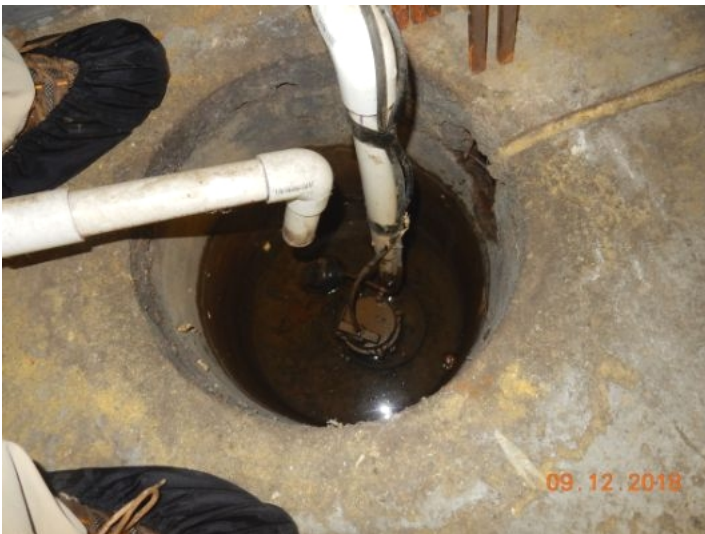
Sump pump float not operating consistently.

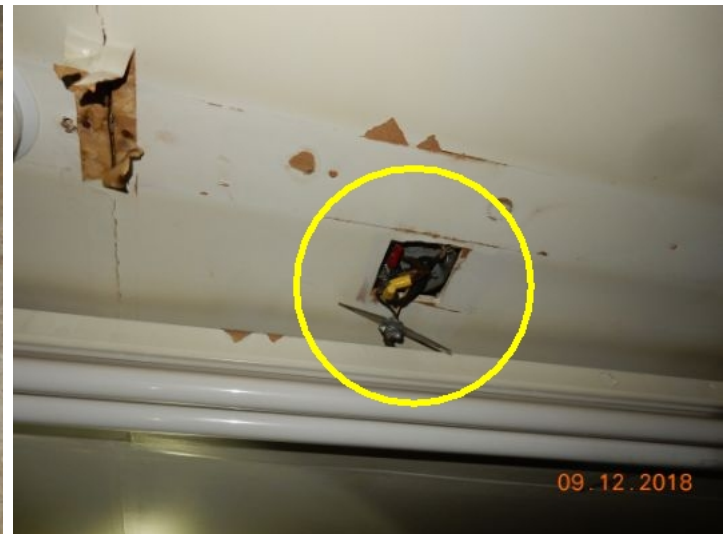
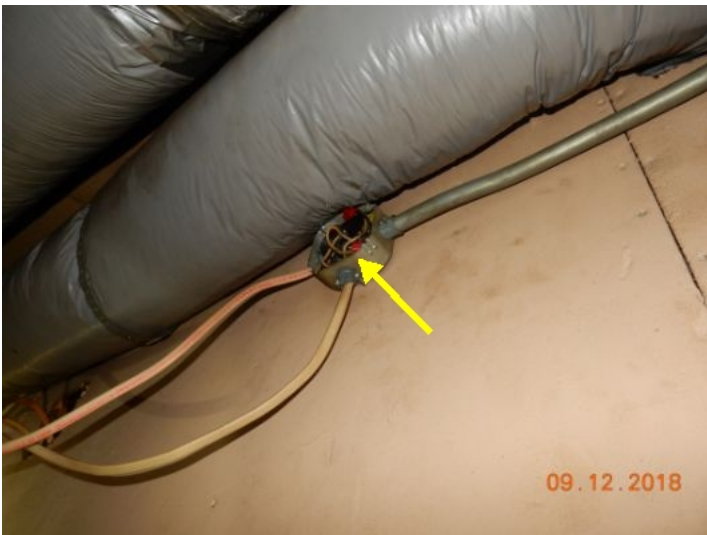
Open junction box - 2nd floor

Open junction box 2nd floor

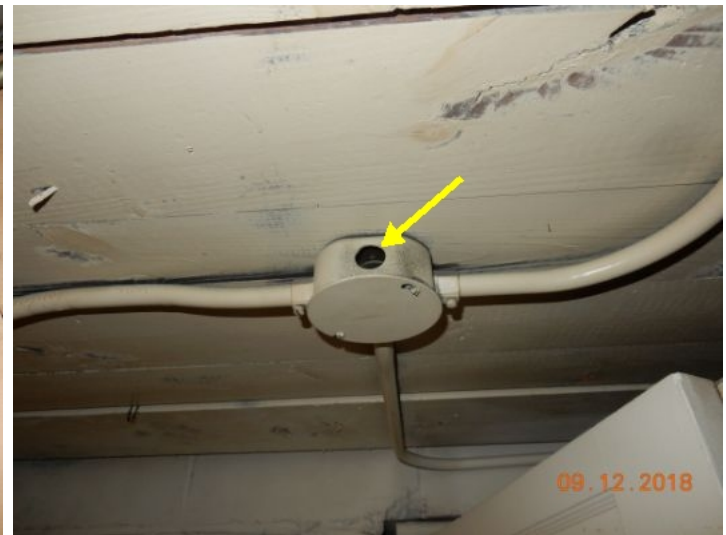
Open knockouts in numerous electrical boxes throughout property.

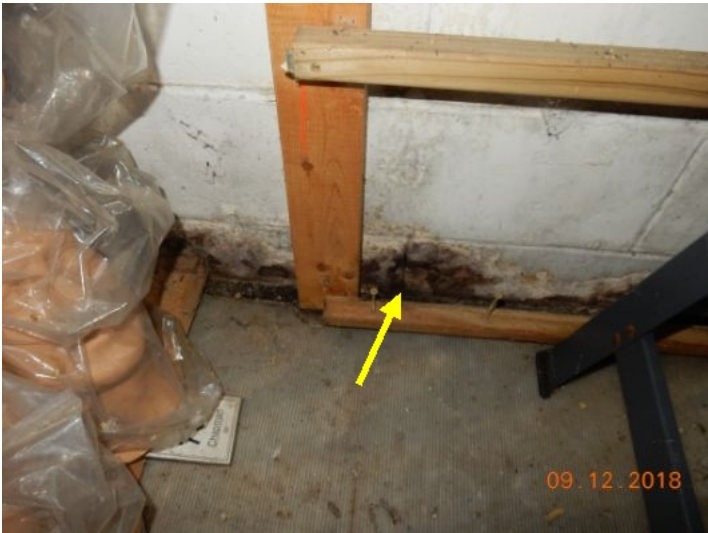
Possible mold present. See notes

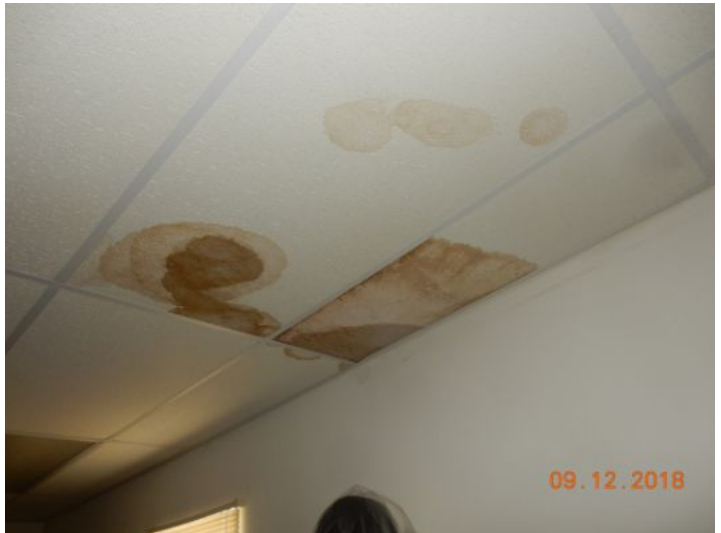
Wall/ceiling moisture stains, tested as 100% moisture content. 2nd floor ceiling Have licensed contractor evaluate/repair.

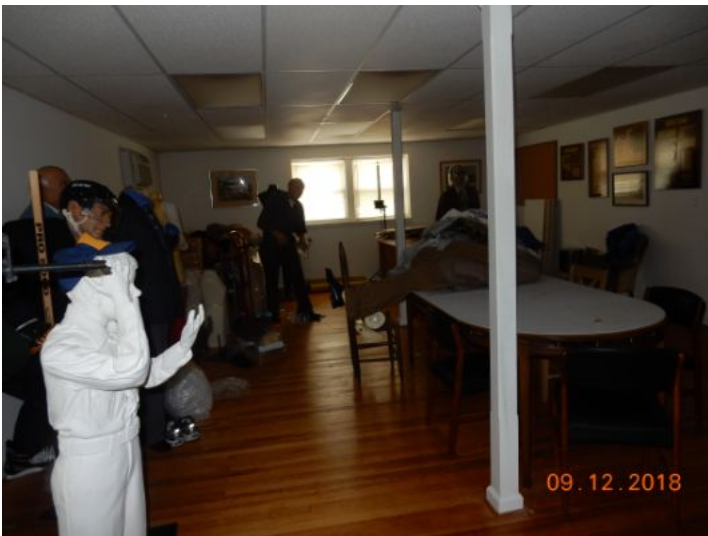
Room with ceiling leak

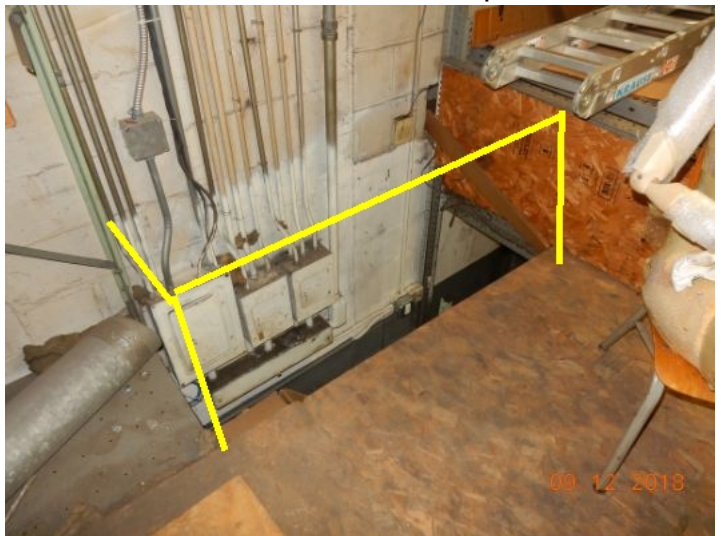
Recommend installation of guard railing at loft opening dropoff.
