Property Inspection Report

Avocet Inspections LLC

123 Commercial Blvd, Baltimore, MD 21222
Inspection prepared for: John Smith - AAA Manufacturing
Date of Inspection: 5/12/2017 Time: 9:30am
Age of Home: C. 1930 Size: 13000+ sq. ft.
Weather: Overcast, light rain, 74°

Note- This was a commercial building inspection performed for informational purposes

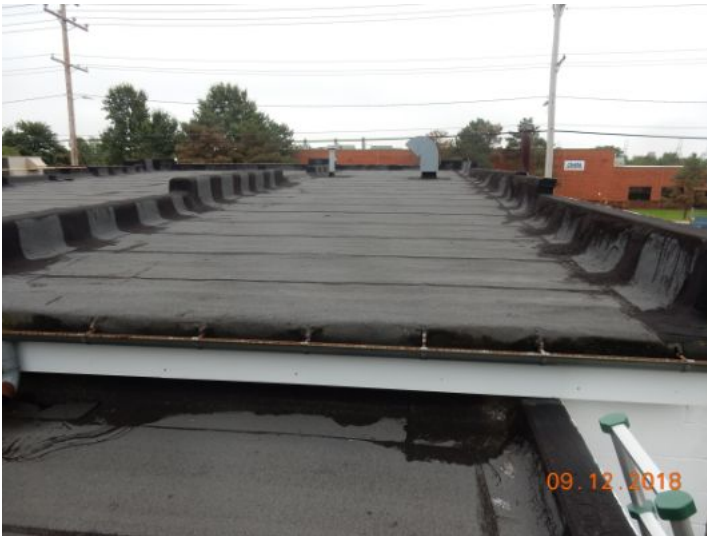
Typical roof view

- **Granulated rubber roofing, older, shows some granulation loss. Cracking of asphalt at seams. Recommend patching cracked asphalt areas. Recommend coating entire roof with white roof coating or other to help seal roofing and prolong useable life span.**

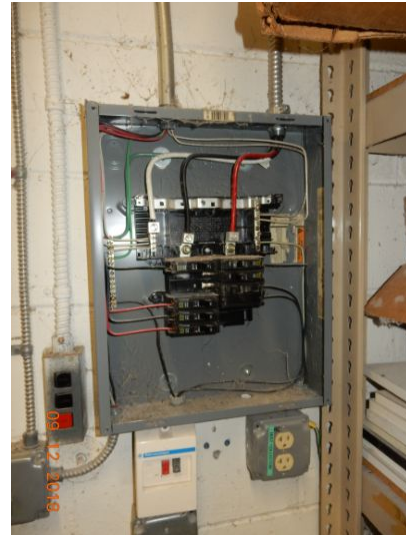
Electrical panel interior - shop/warehouse

- **Open knockouts panel enclosure, electrocution hazard, install proper filler plates. - 2nd floor**
- **Open knockouts panel enclosure, electrocution hazard, install proper filler plates. Shop/warehouse**

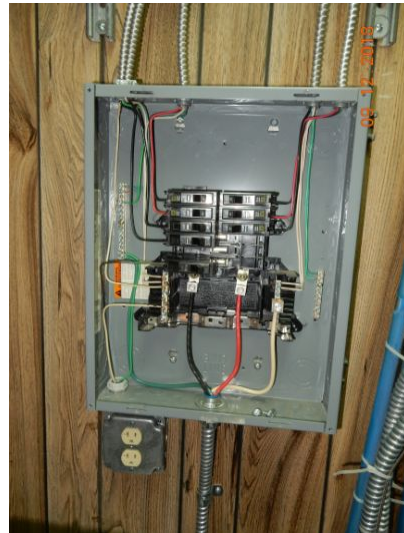
Electrical panel interior - 2nd floor

Open knockouts panel enclosure, electrocution hazard, install proper filler plates. - 2nd floor

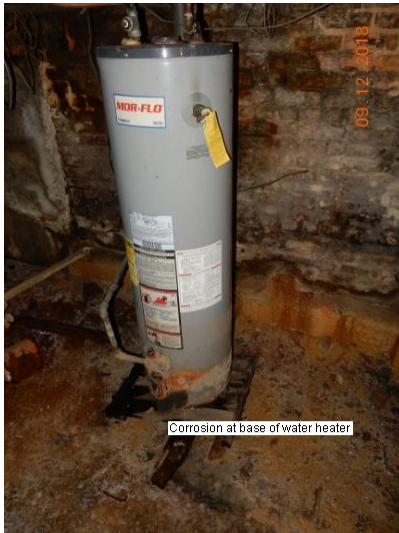
Water heater mfg. date(s) - 2007

- **Corrosion at base of water heater in basement. When installing next water heater consider raising higher off floor to help protect from wet conditions.**
